SHELL OVERHEATING ADJACENT TO MANWAY

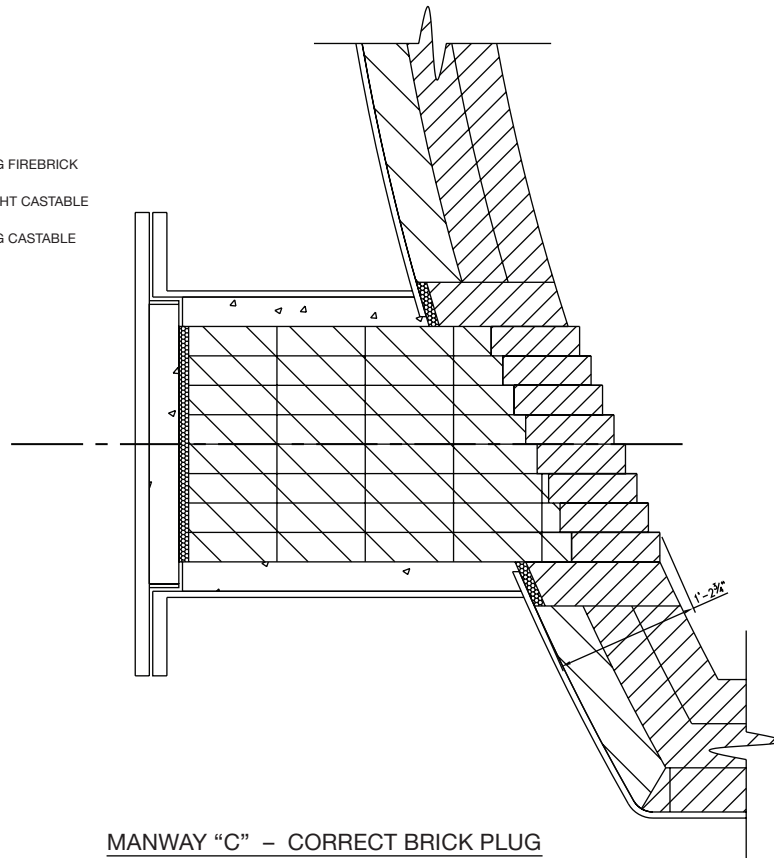
After inspecting the refractory plug that was inserted in the manway and referring to the design drawing for the furnace brick work details, the reason for the hot spot on the shell was obvious. A square ended plug had been inserted in the manway of the dished head of the furnace until it lined up with the upper bricks in the manway. This resulted in the plug only partially covered the bottom of the manway brick lining and did not provide a sufficient thickness of refractory lining between the gas and shell on the bottom side of the manway. The heat, from the hot furnace gas, penetrated the refractory at bottom of the manway and overheated the metal in the furnace shell.
