## **SIGHT PORT FAILURES ON COMBUSTION CHAMBERS IN SPENT ACID REGENERATION (SAR) FACILITIES**

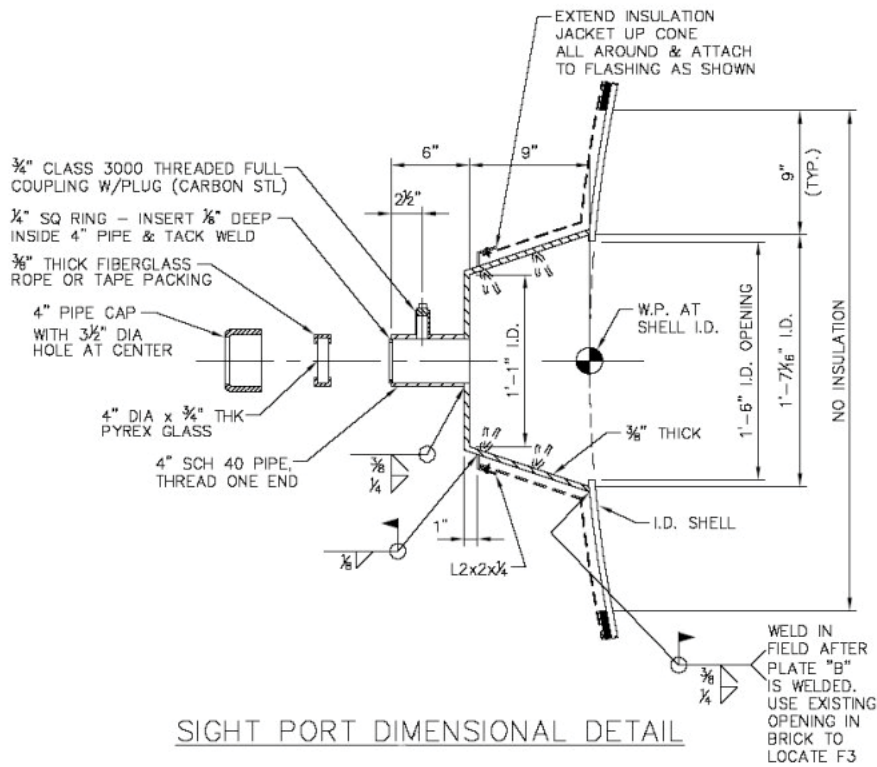
SIGHT PORT DIMENSIONAL DETAIL

Findings following an operational failure of several site glass ports on combustion chambers at operating spent acid regeneration (SAR) plants established the root cause as over-heating of the combustion/decomposition vessel. The sight port nozzle is particularly sensitive to the combination of internal refractory and external insulation. If external insulation is excessive and/or internal refractory is minimal the result is overheating of the metal surface of the combustion chamber/decomposition furnace. Failure of the site ports and surrounding metal shell can result. Collateral damage to the refractory can further damage the metal shell.

To further reduce the risk of overheating the combustion chamber shell, MECS has re-designed the sight glass detail and associated refractory lining. Sketches attached highlight those changes. These details will yield a more robust site port design that is less likely to overheat during operation.
