### IMPROPER CONTROL VALVE LOCATION

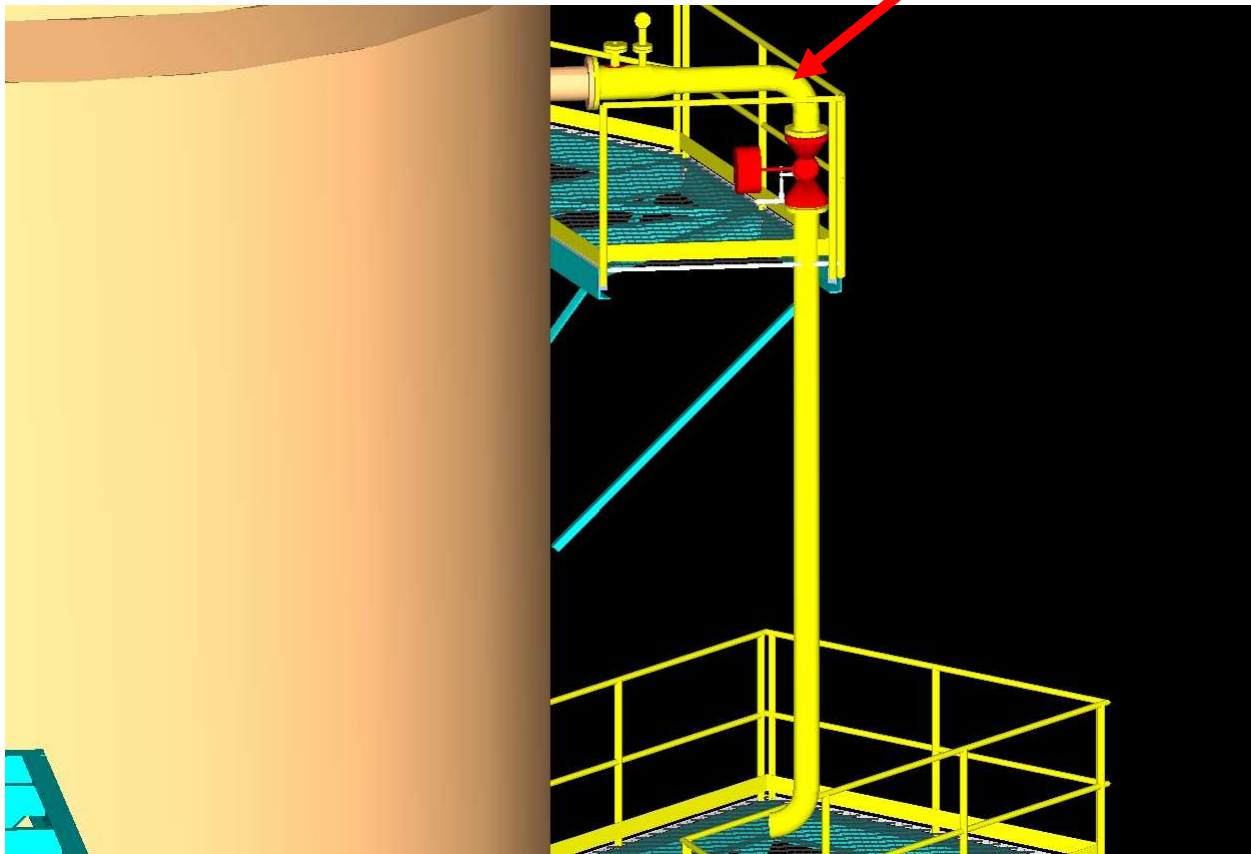
**Incorrect valve location**

On a recent project the customer's specification required that all control valves be located where they had access from a platform. The safety of the people working on the valve was the first priority. There was an available platform on top of the tower and the flow control valve was located at this position just upstream of a pipe elbow. The new location of the valve violated a rule of thumb that control valves should be located up stream of straight pipe runs. Unfortunately this location of the valve set up eddy currents in the elbow and the wall of the pipe eroded/corroded after several months of operation resulting in an acid leak.

**LEAK**
